# Manhole Inspection Summary

Manhole # S21K\_\_010MH

Insp Date: **4/3/08 2:24 PM**

**Location** Address: **302 s fulton st**

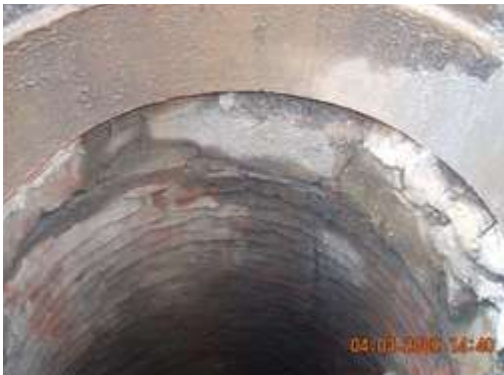
Defect 3

Condition: ☐ Sound ☐ Cracked ☐ Root Intrusion ☐ Loose Brick ☒ **Deteriorated**

Infiltration: ☐ None ☒ **Joint** ☐ Cracks ☐ Mortar ☐ Roots ☐ Wall

infiltration @ chimney joint

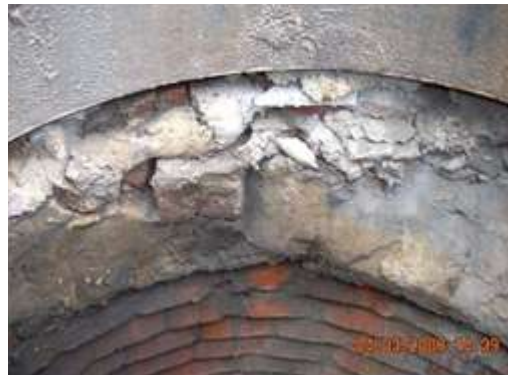
Defect 2

deteriorated chimney

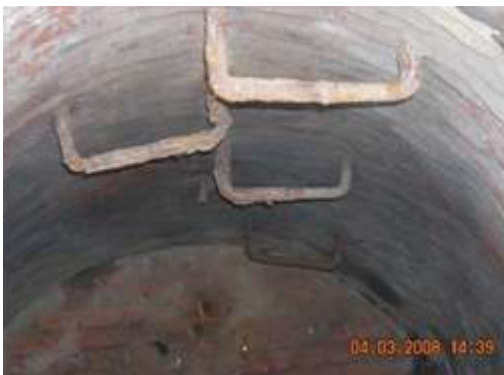
Defect 1

Infiltration: ☐ None ☐ Joint ☐ Cracks ☐ Mortar ☐ Roots ☒ **Wall**

Count: **4** Missing: **1** ☒ **Corroded**

signs of barrel infiltration, corroded and missing steps
